LACK OF MOVEMENT JOINTS CAUSES MULTIPLE CRACKING OF CALCIUM SILICATE BRICKWORK

Client: Oxford City Council
Location: Oxford

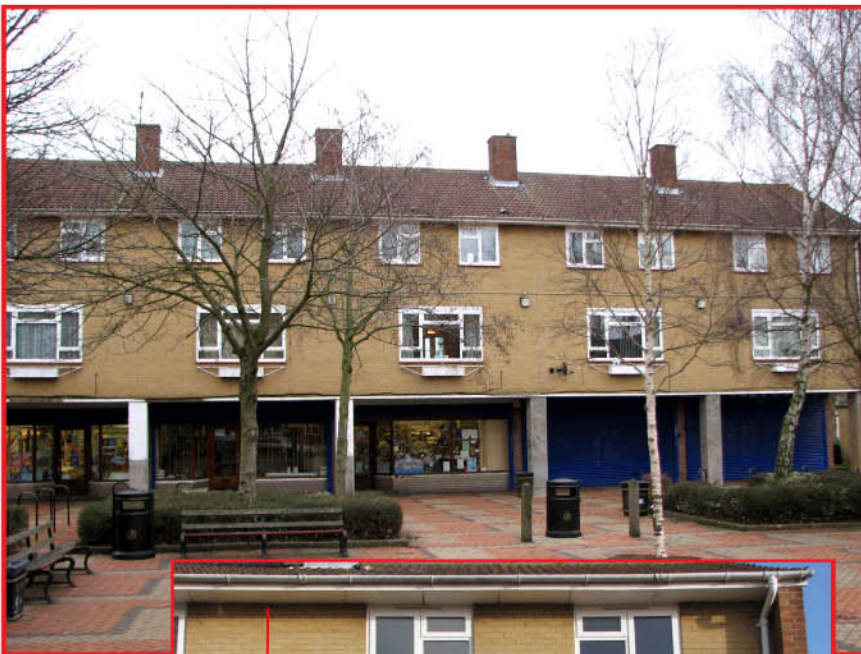
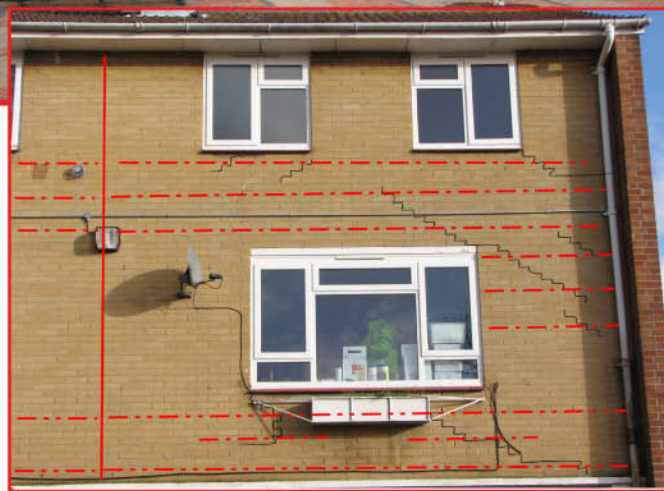
A parade of five shops with two stories of flats above, constructed using calcium silicate bricks in the early 1970's, was suffering from extensive masonry cracking.

This was caused by shrinkage of the bricks over time and the lack of any movement joints across the width of the five properties, combined with some deflection of the support beams.

- Helifix engineers devised the repair, undertaken by the Approved Installer, causing minimal disruption to the occupants or the structure and allowing the shops to remain open throughout.
- To stitch all the stepped cracks, single HeliBars were grouted into mortar beds at three levels between the first and second storey windows and double lengths at two levels below first floor windows across the entire front elevation. Single short HeliBars were used in other locations.
- Full height movement joints were created between each property by cutting vertical channels, stabilised each side with DryFix ties. Movement joints sets were installed with 400mm HeliBars bonded across the joint, at various levels, with one end free to move inside a special sleeve, before filling the joint with flexible mastic to complete full structural stabilisation.
