SIGNIFICANT STRUCTURAL FAULTS OVERCOME DURING BARN CONVERSION

Client: Private homeowner
Location: Puckrup, Tewkesbury

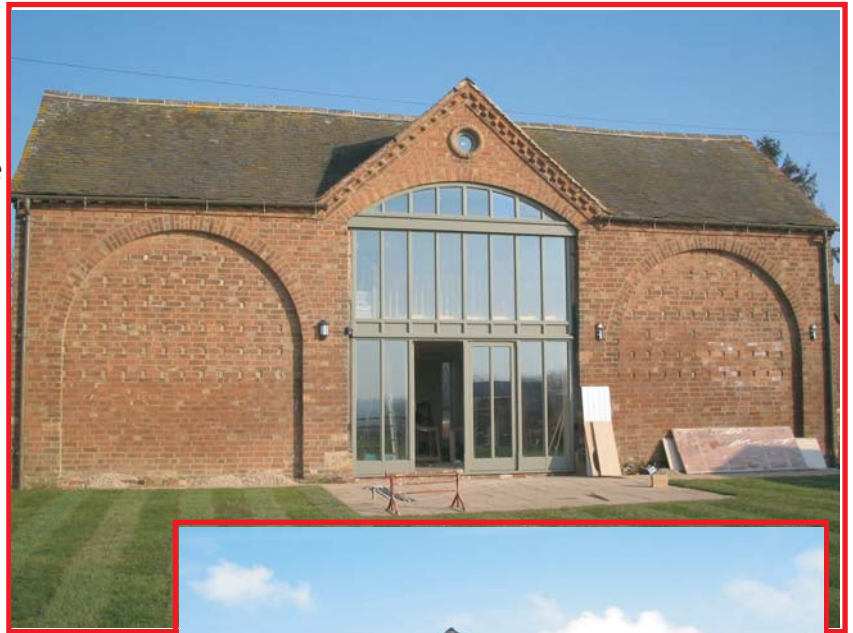
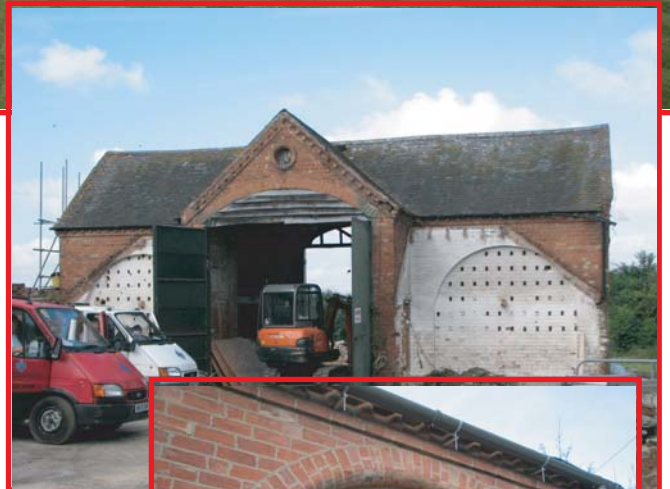
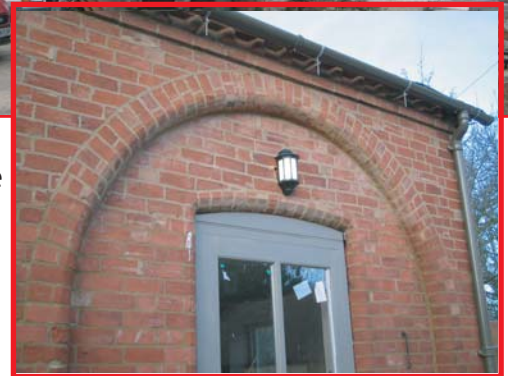
A 100 years old dilapidated brick barn, suffering from a wide range of structural faults, needed to be stabilised prior to its conversion into a modern private residence.

The double storey barn was affected by historic settlement that had resulted in failed arch lintels, relaxed arches, cracked and failed masonry and a loss of lateral restraint to the main rear elevation.

- Helifix engineers devised a sympathetic repair programme using the concealed Helibeam System to secure the structure
- To secure and reinforce the brickwork and reinstate lintels, long length HeliBars were bonded into channelled-out mortar beds at various levels, forming masonry beams to distribute the structural loads. Individual cracks were stitched using shorter HeliBars and the failed arches re-pinned with DryFix ties.
- To stabilise the rear elevation, that was held in place with scaffold props, BowTies were installed through clearance holes in the masonry and driven into the ends of internal roof beams and joists before being bonded to the brickwork. Grouted CemTies were also used to reconnect separated walls and further secure the main elevations
